United States
Environmental Protection
Agency

TS-AMD-86/29-2
November 1986

AERIAL PHOTOGRAPHIC ANALYSIS OF U.S. SCRAP Chicago, Illinois

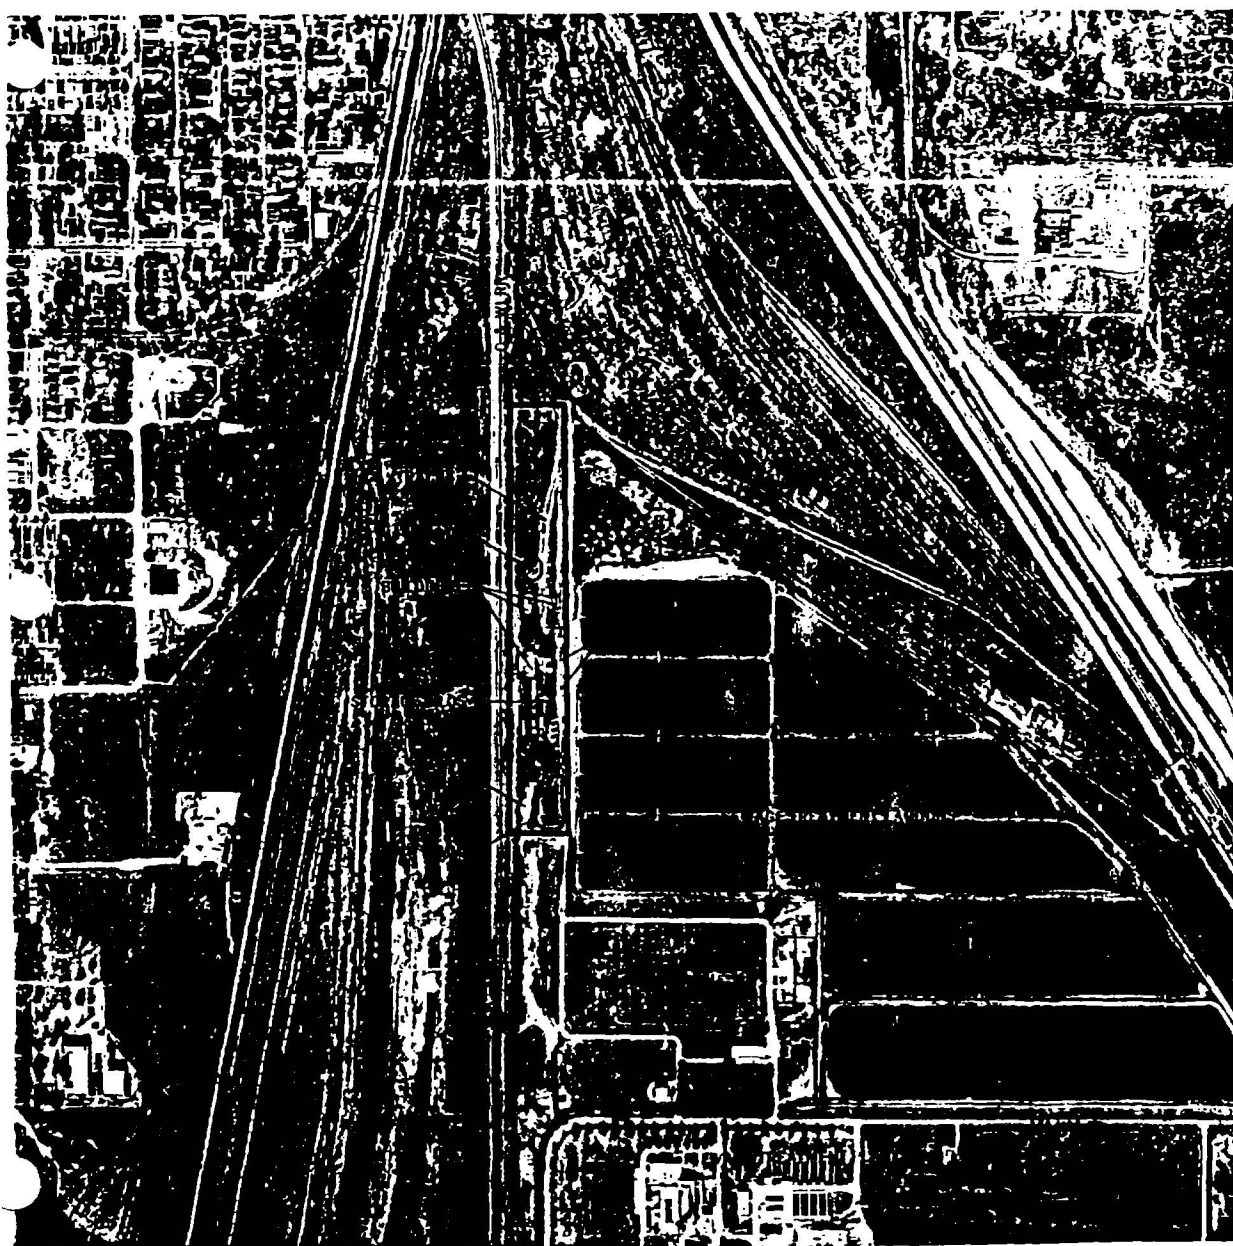
Figure 5. U.S. Scrap, September 14, 1959. Approximate scale 1:6,100.

The 1959 photograph (Figure 4) shows very little change to closed malting facility. Dumping of fill material and other debris is now evident at this site. Light-toned ground stains at the southwest corner of the site suggest liquid dumping (annotation A); however, no earthmoving vehicles or waste hauling trucks are visible.

Additional dumping of fill material northeast of the study site has continued (annotation B).

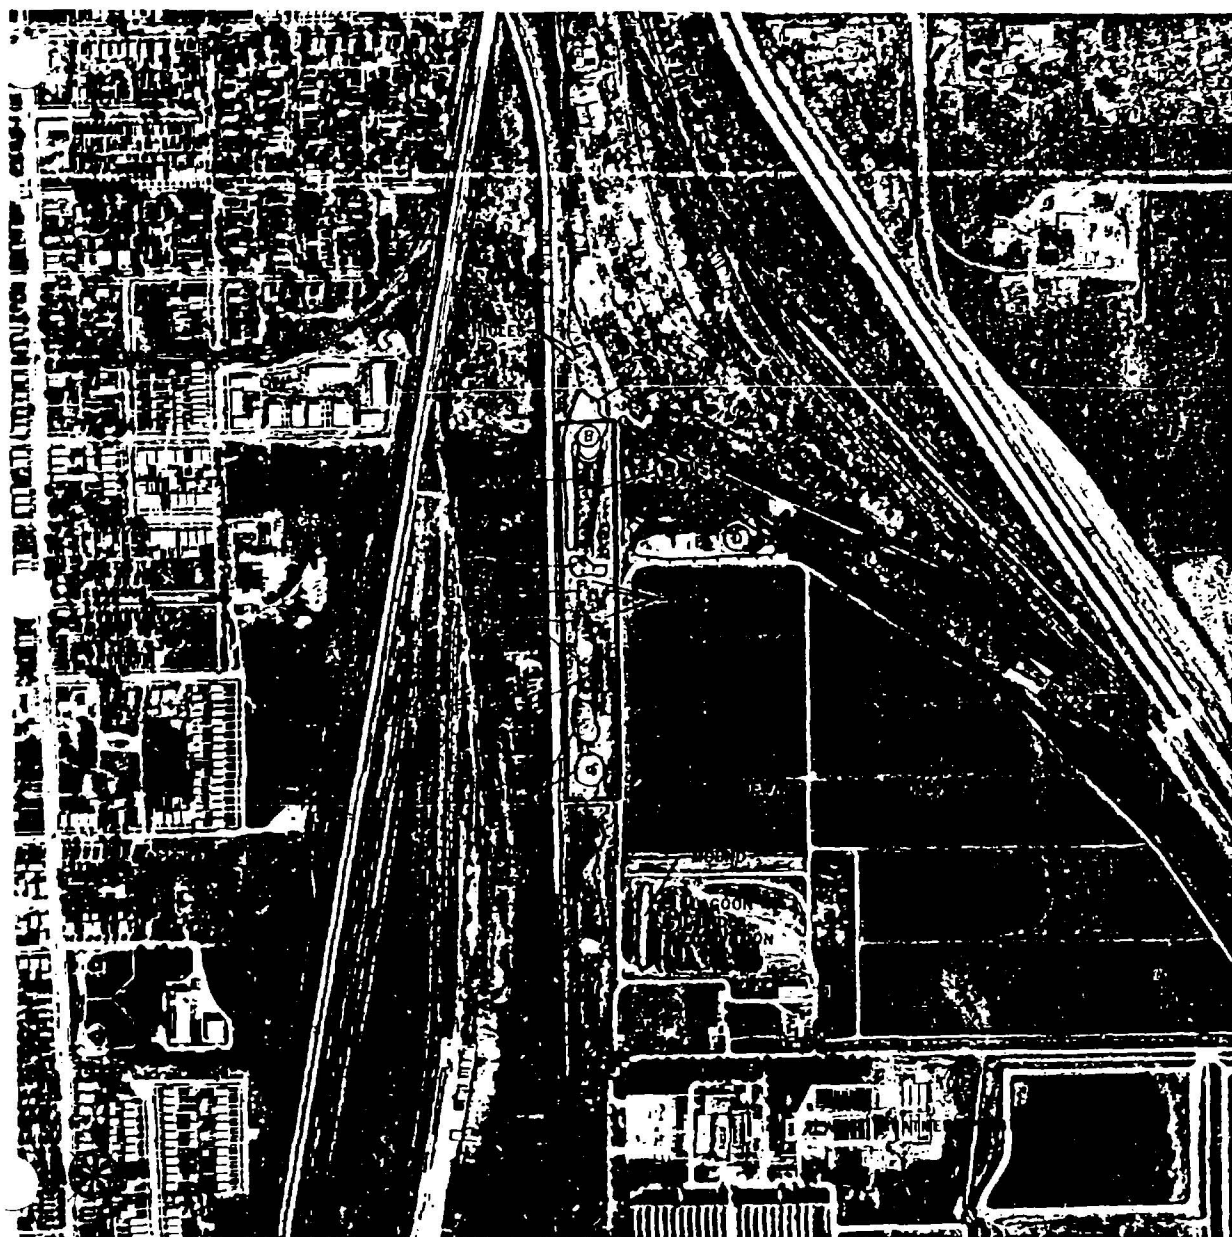
Figure 7. U.S. Scrap, August 28, 1967. Approximate scale 1:6,700.

The 1967 photograph (Figure 7) shows the study site is now an active waste disposal facility. The abandoned malt processing building has been dismantled but the 12 concrete storage silos remain standing. The area around the building foundation is covered with construction rubble and piles of debris. A large pit has been dug at the north end of the facility (annotation A). A mound of light-toned rubble, fill, and waste lies along the north and west sides of the pit (annotation B). The bottom of this pit appears to contain dark liquid. Numerous vehicles are visible throughout the facility showing a high level of activity.

Large mounds of fill have been deposited to the south (annotation C) and northeast (annotation D) of the facility. This earthmoving activity is apparently associated with the construction of another sewage treatment lagoon (annotation E).

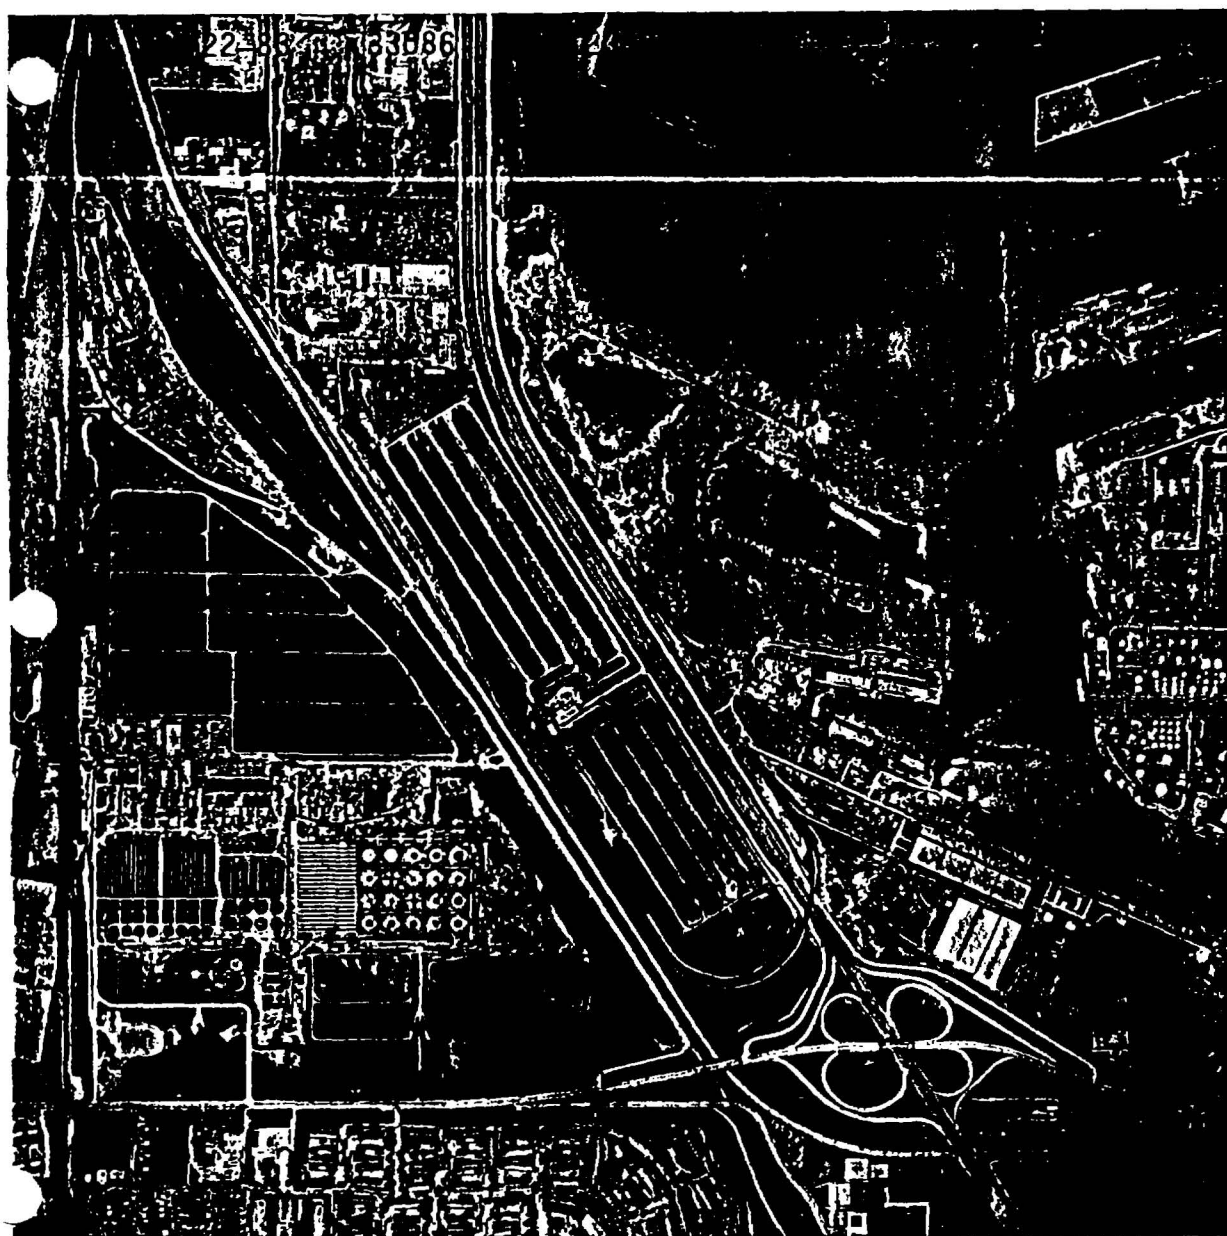
Figure 11. U.S. Scrap, July 23, 1983. Approximate scale 1:12,000.

The 1983 photograph (Figure 11) shows no significant changes at the study area as a 1980 (Figure 10). The southern portion of the site now has vegetation overgrowth suggesting the site is abandoned. Surface runoff continues to collect at the site's south end. The vegetation around the landfill disposal mound at the north end of the site is irregular. Piles of debris are still visible but these too are becoming overgrown. The two small pits/depressions at the center of this abandoned facility contain standing liquid (annotation A). No signs of leachate seepage associated with disposal activity at this site are identified.
